An investigation of wind turbine blade erosion due to rain and weathering

Grant Leishman

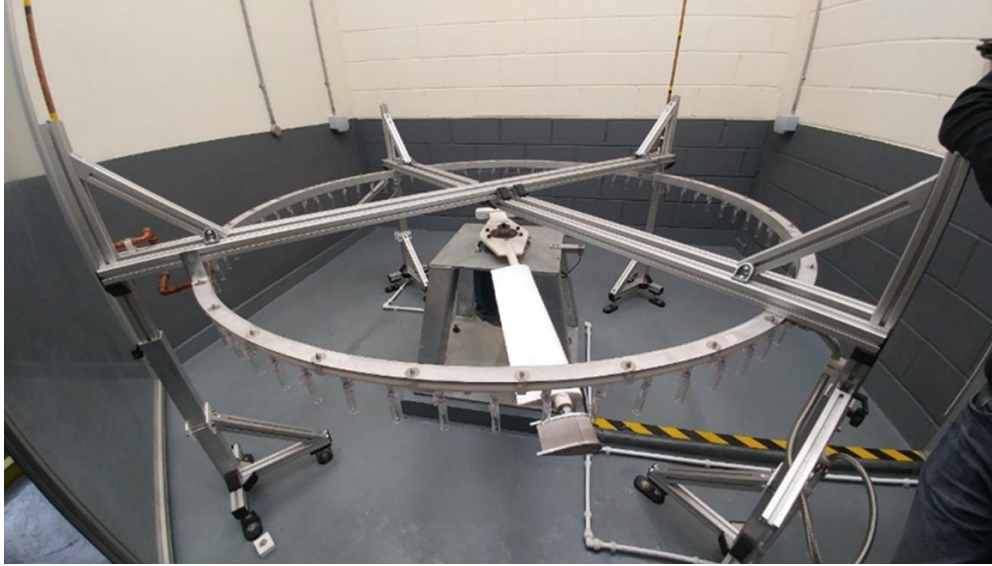
Accelerated Rain Erosion

- 72 Needles
- Up to 1400rpm
- Changeable droplet rate, size and height
- 30 minutes from Strathclyde

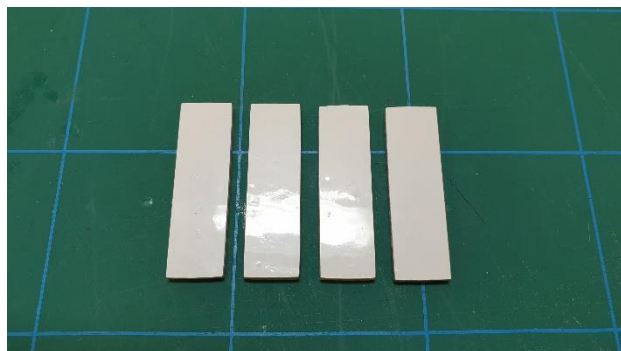
Stage 1

Rain Eroded Test Specimens
