Wind Turbine Amplitude Modulated Noise - AM

Dr Jeremy H Bass, MInstP, MIOA
Head of Specialist Services

13 January 2016, FutureWind 2016
University of Strathclyde, Glasgow, UK

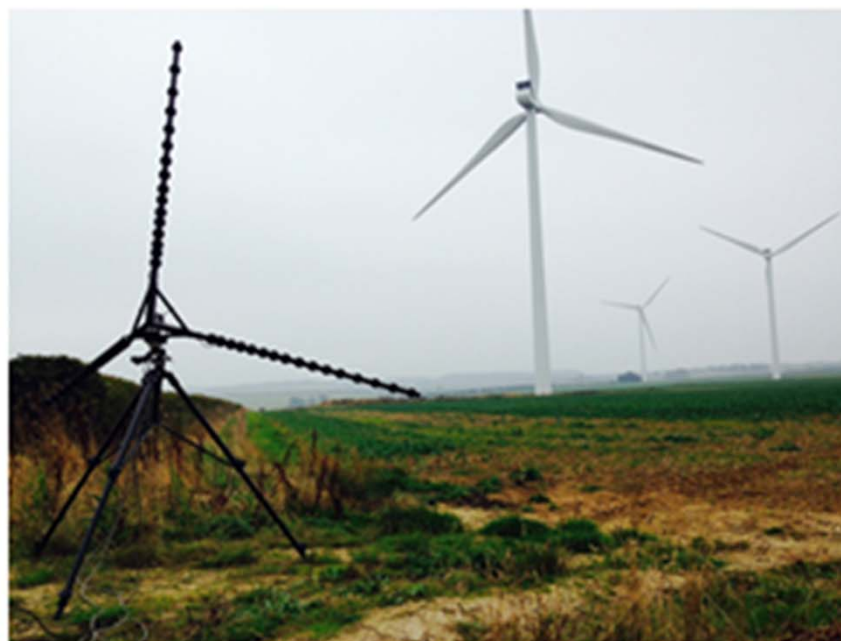
6.2A GFal Acoustic Camera

- Star Array, 48 microphone system
- Three turbines measured: T5, T8, T9, each from different viewpoints.
- 192 kHz sampling
- 32 second measurements covering three full rotations of the turbine blades
- Analysis includes spectrograms, specific region analysis and searching for blade swish and blade passing frequency
- Acoustic photos and movies

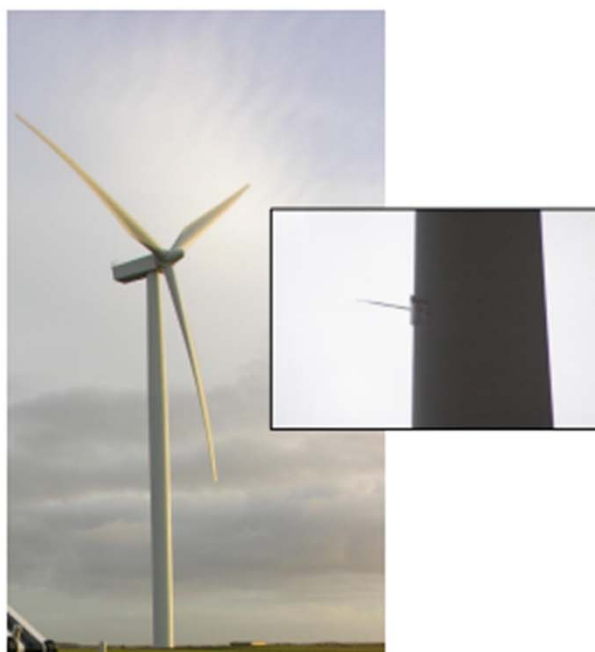
One pitot tube on the
Siemens 3.6 MW turbine

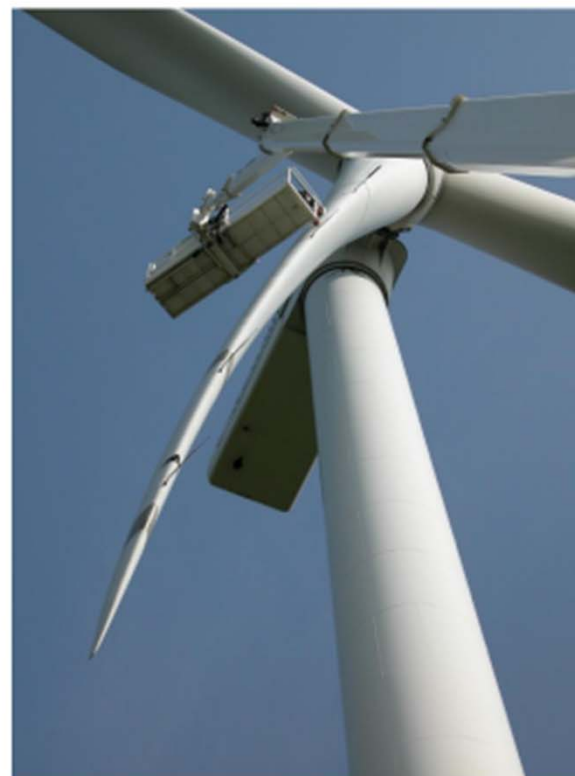
4 pitot tubes on the 80m, 2MW,
NM80 turbine
